TERRACED VINEYARDS: ASSESSMENT OF THE CURRENT SITUATION IN RELATION TO CLIMATE CHANGES IN THE PRIMORSKA REGION, SLOVENIA

Mojca Mavrič Štrukelj¹, Andreja Škvarč²

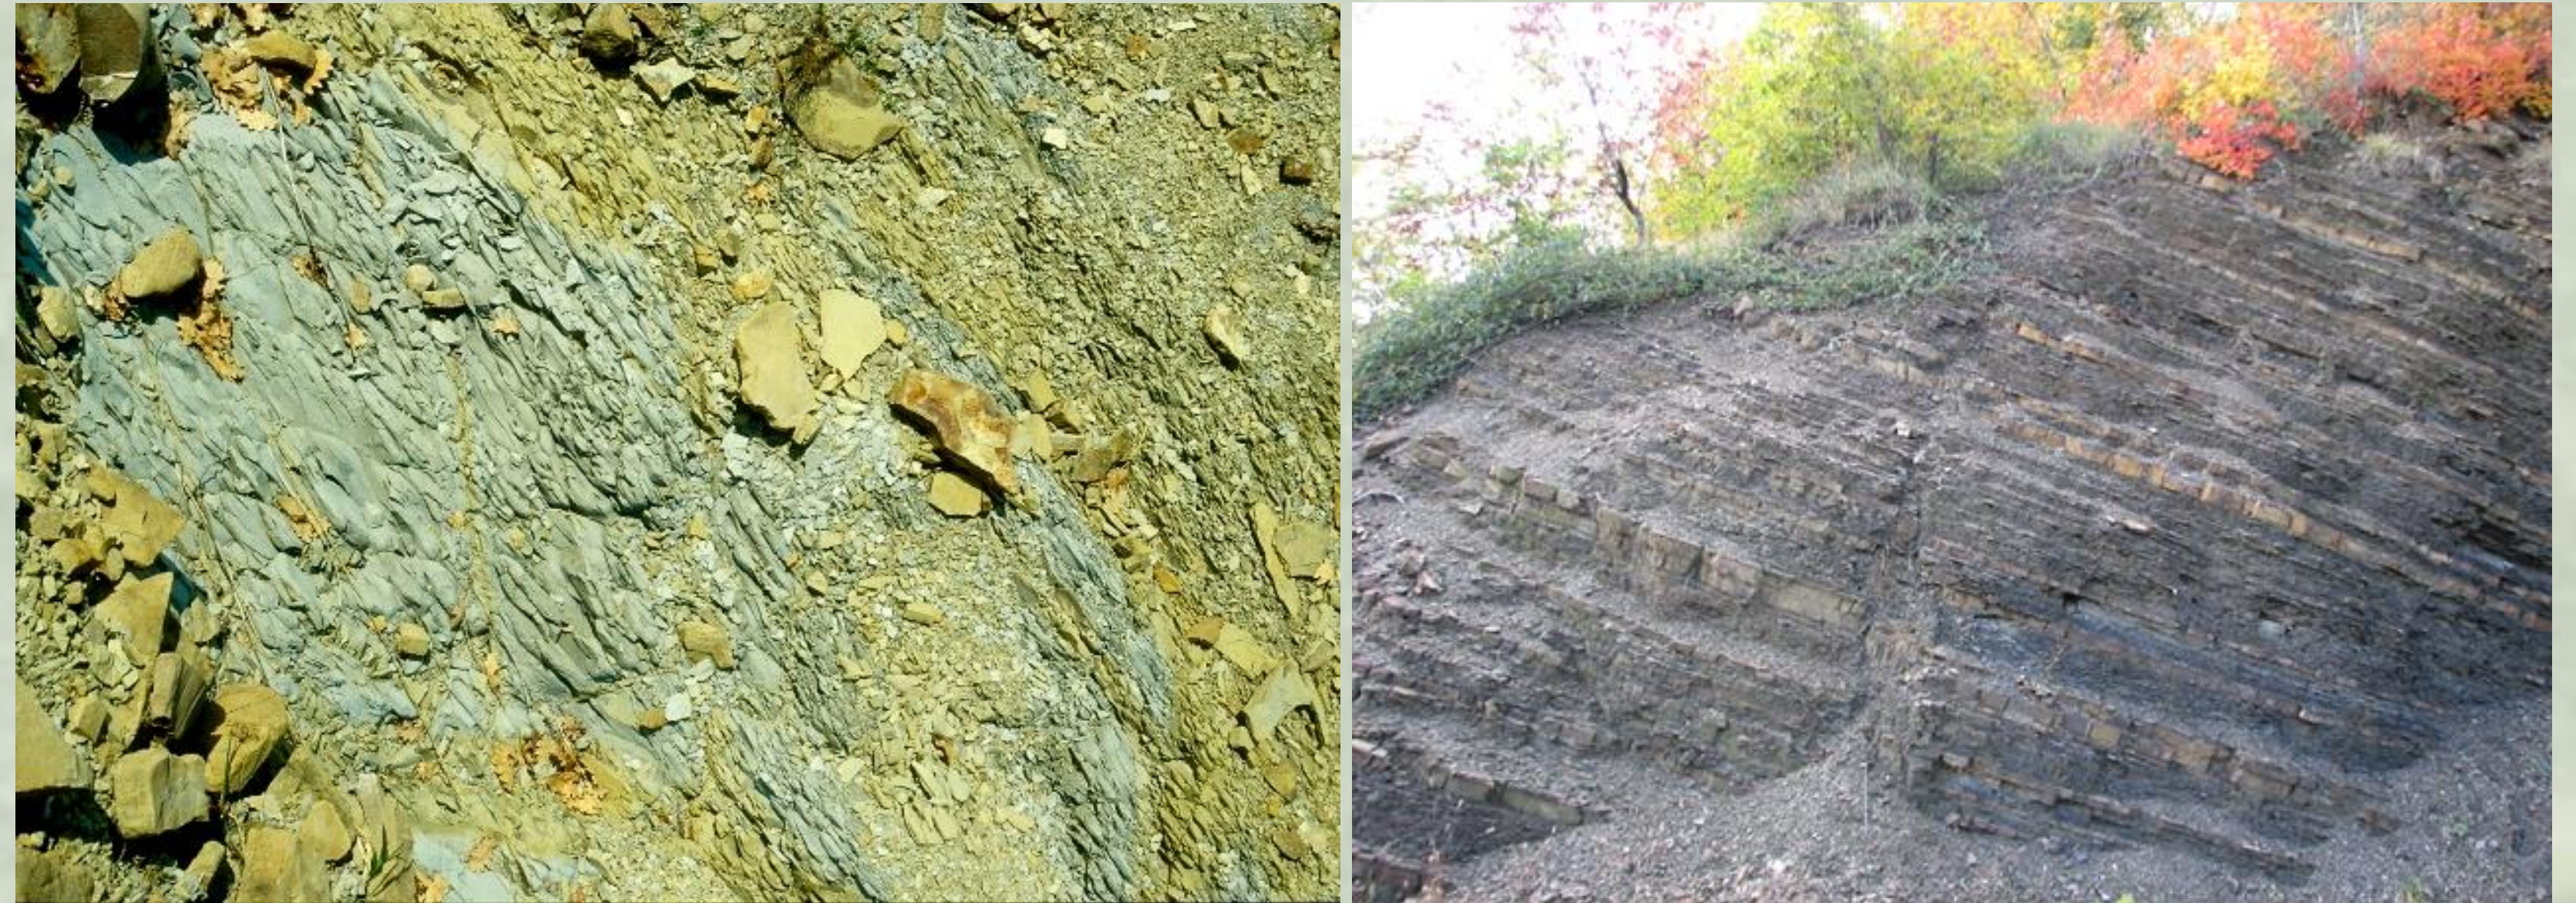
Figures 1 in 2: Grey Marl (left) and Flysch layers composed of marl and sandstone (right)

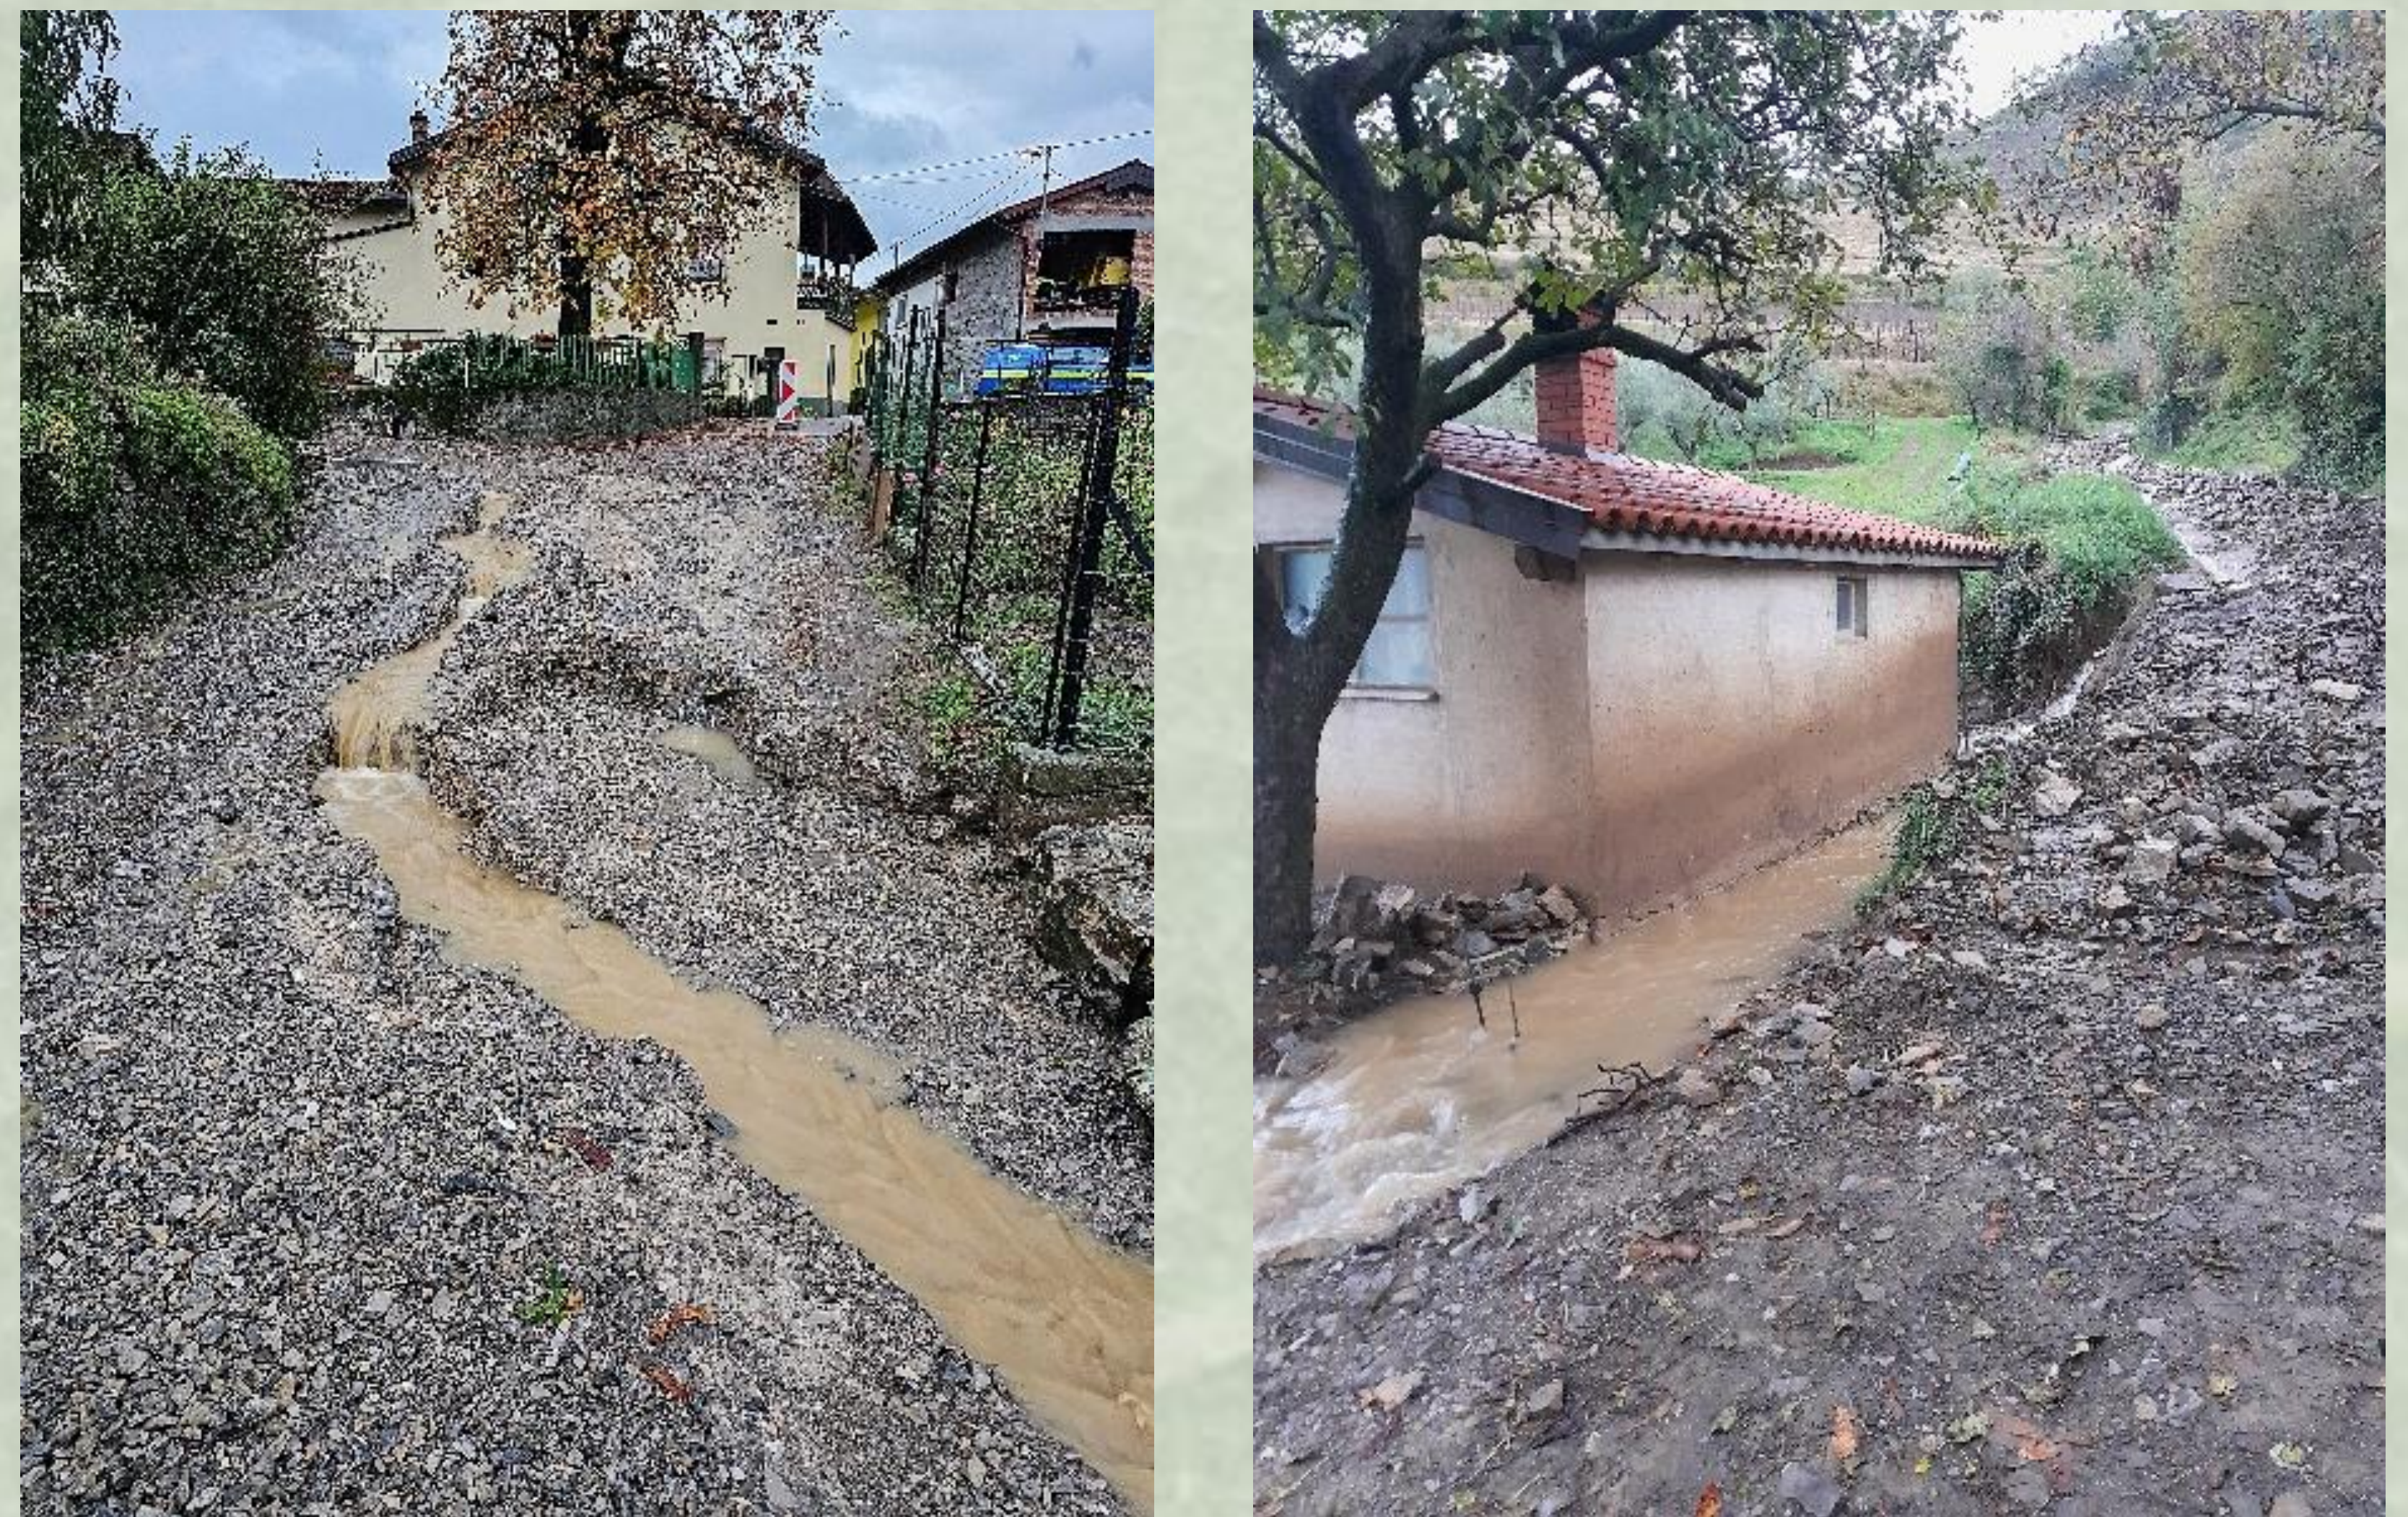
Figures 3 and 4: Soil erosion on flysch during intense rainfall in the village of Zavino, Vipavska dolina in 2023 (Photo: Bratašev, M. Civil Protection of the Municipality of Ajdovščina)

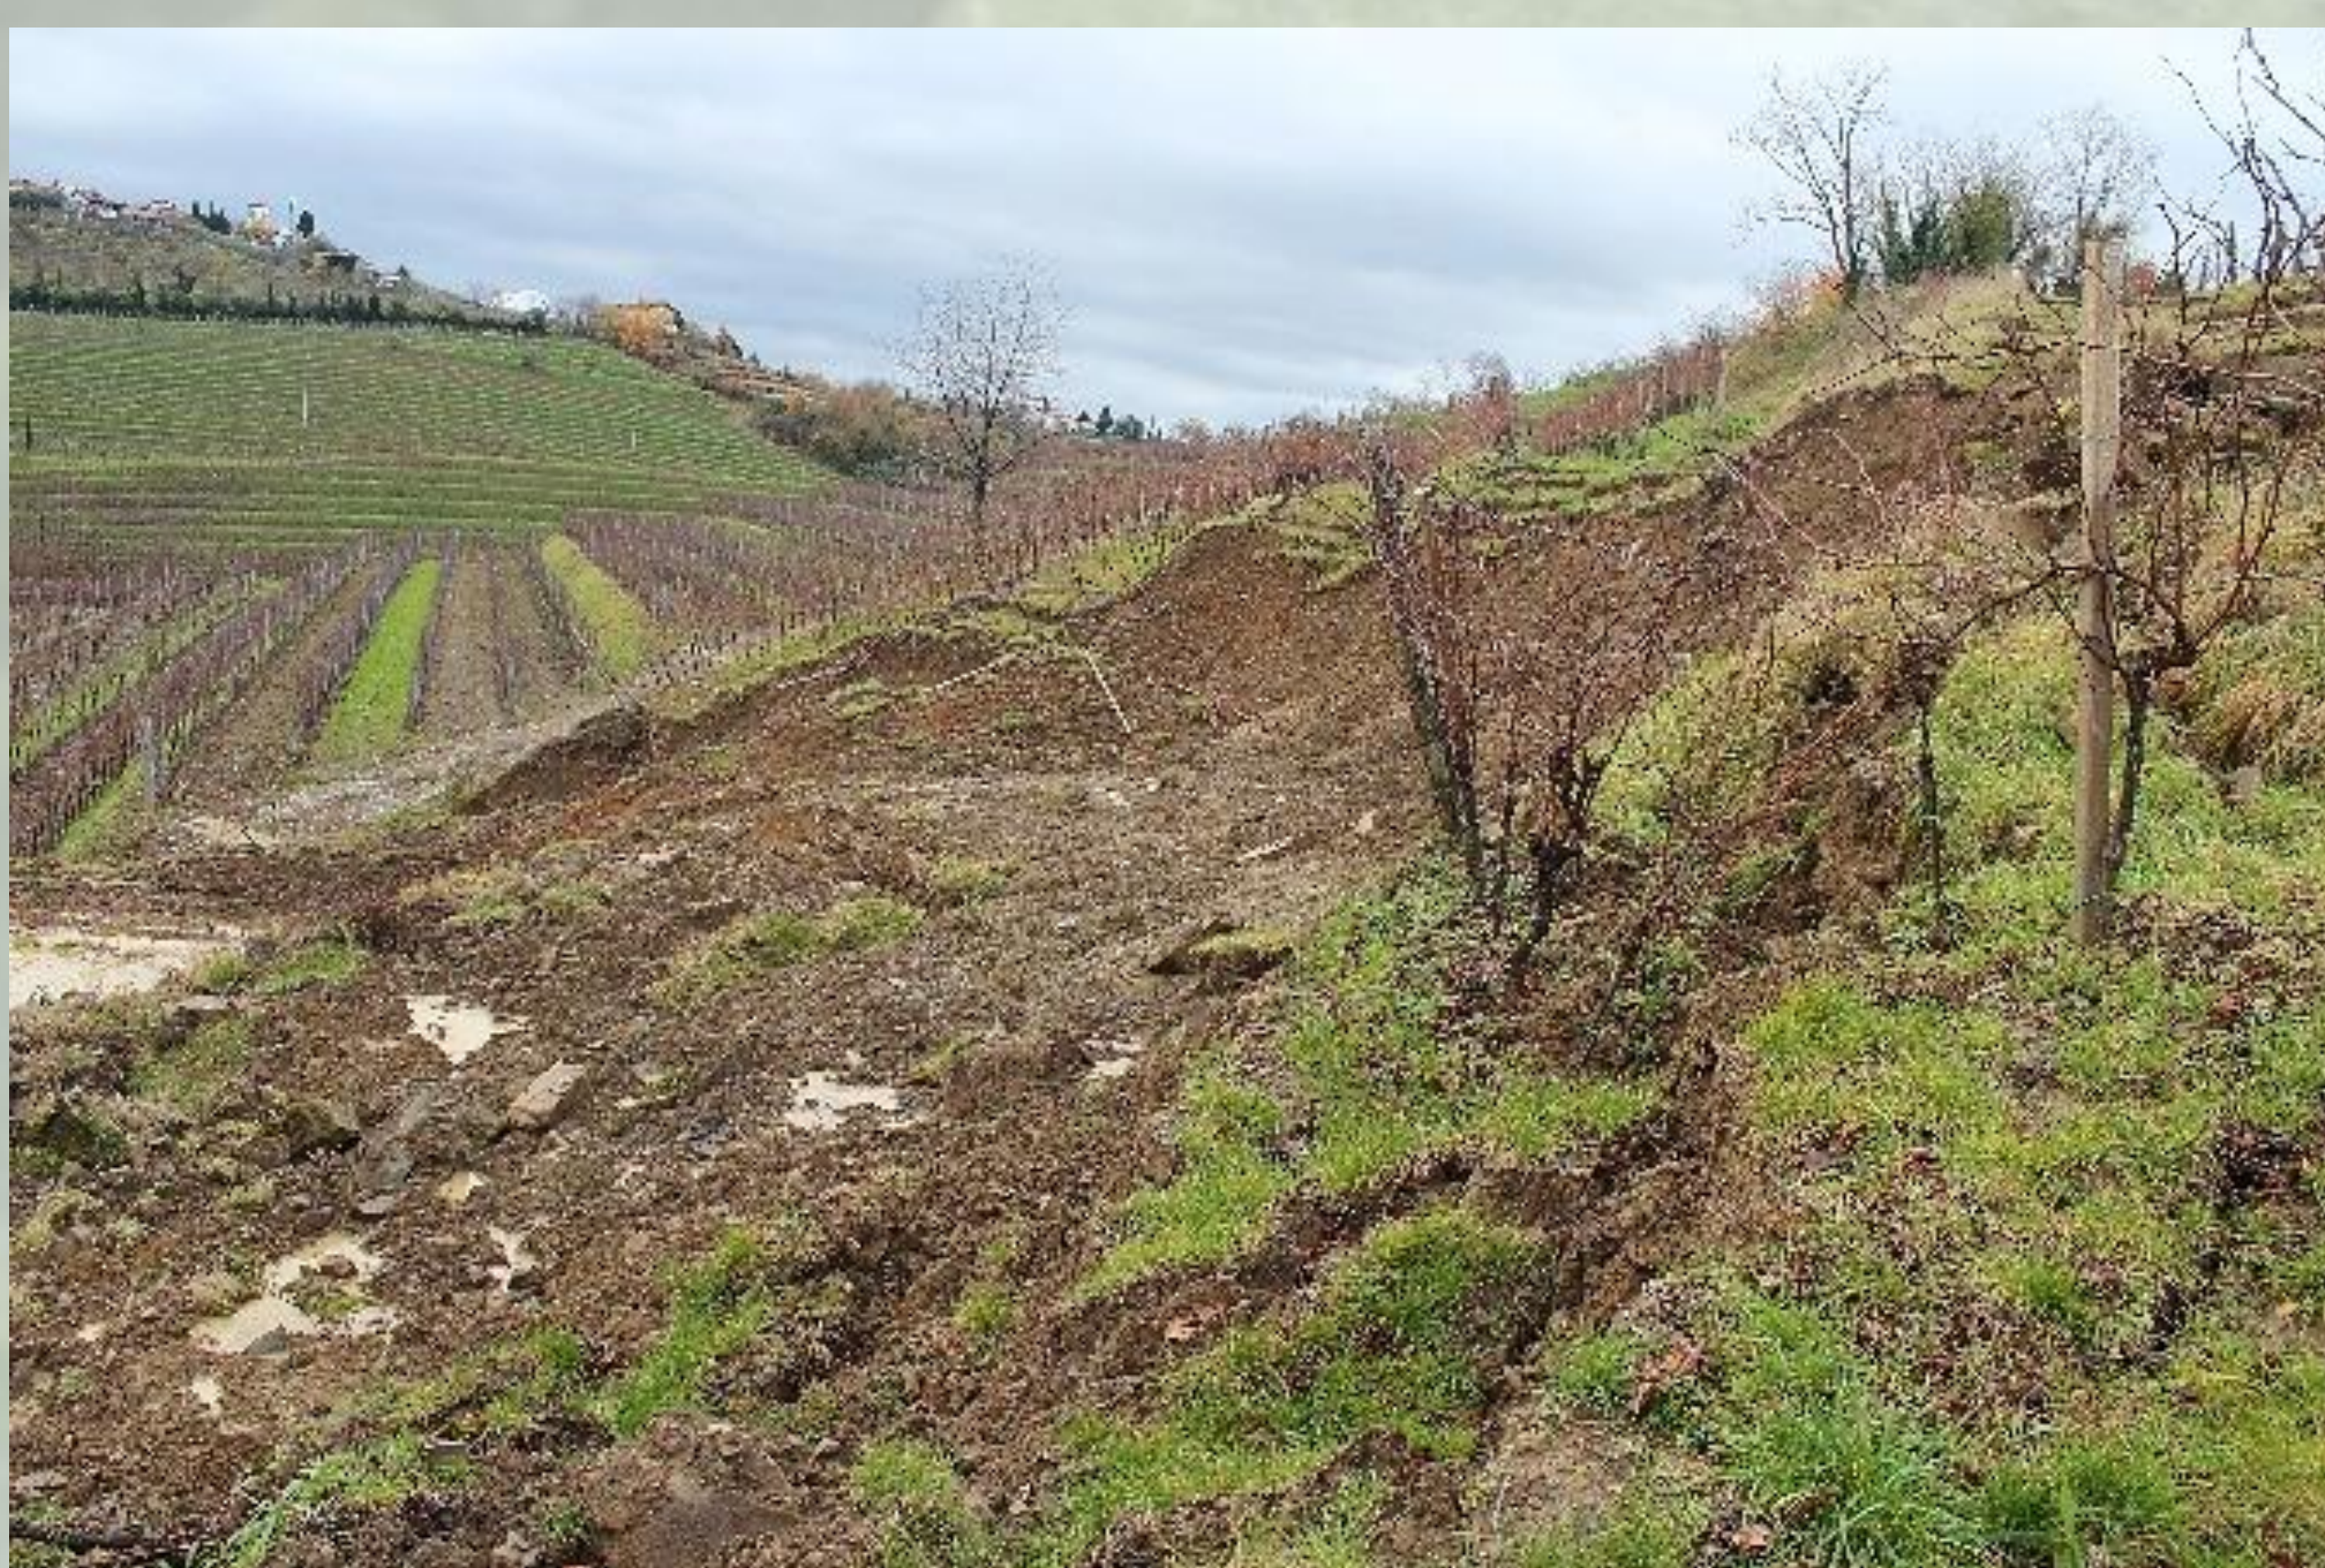
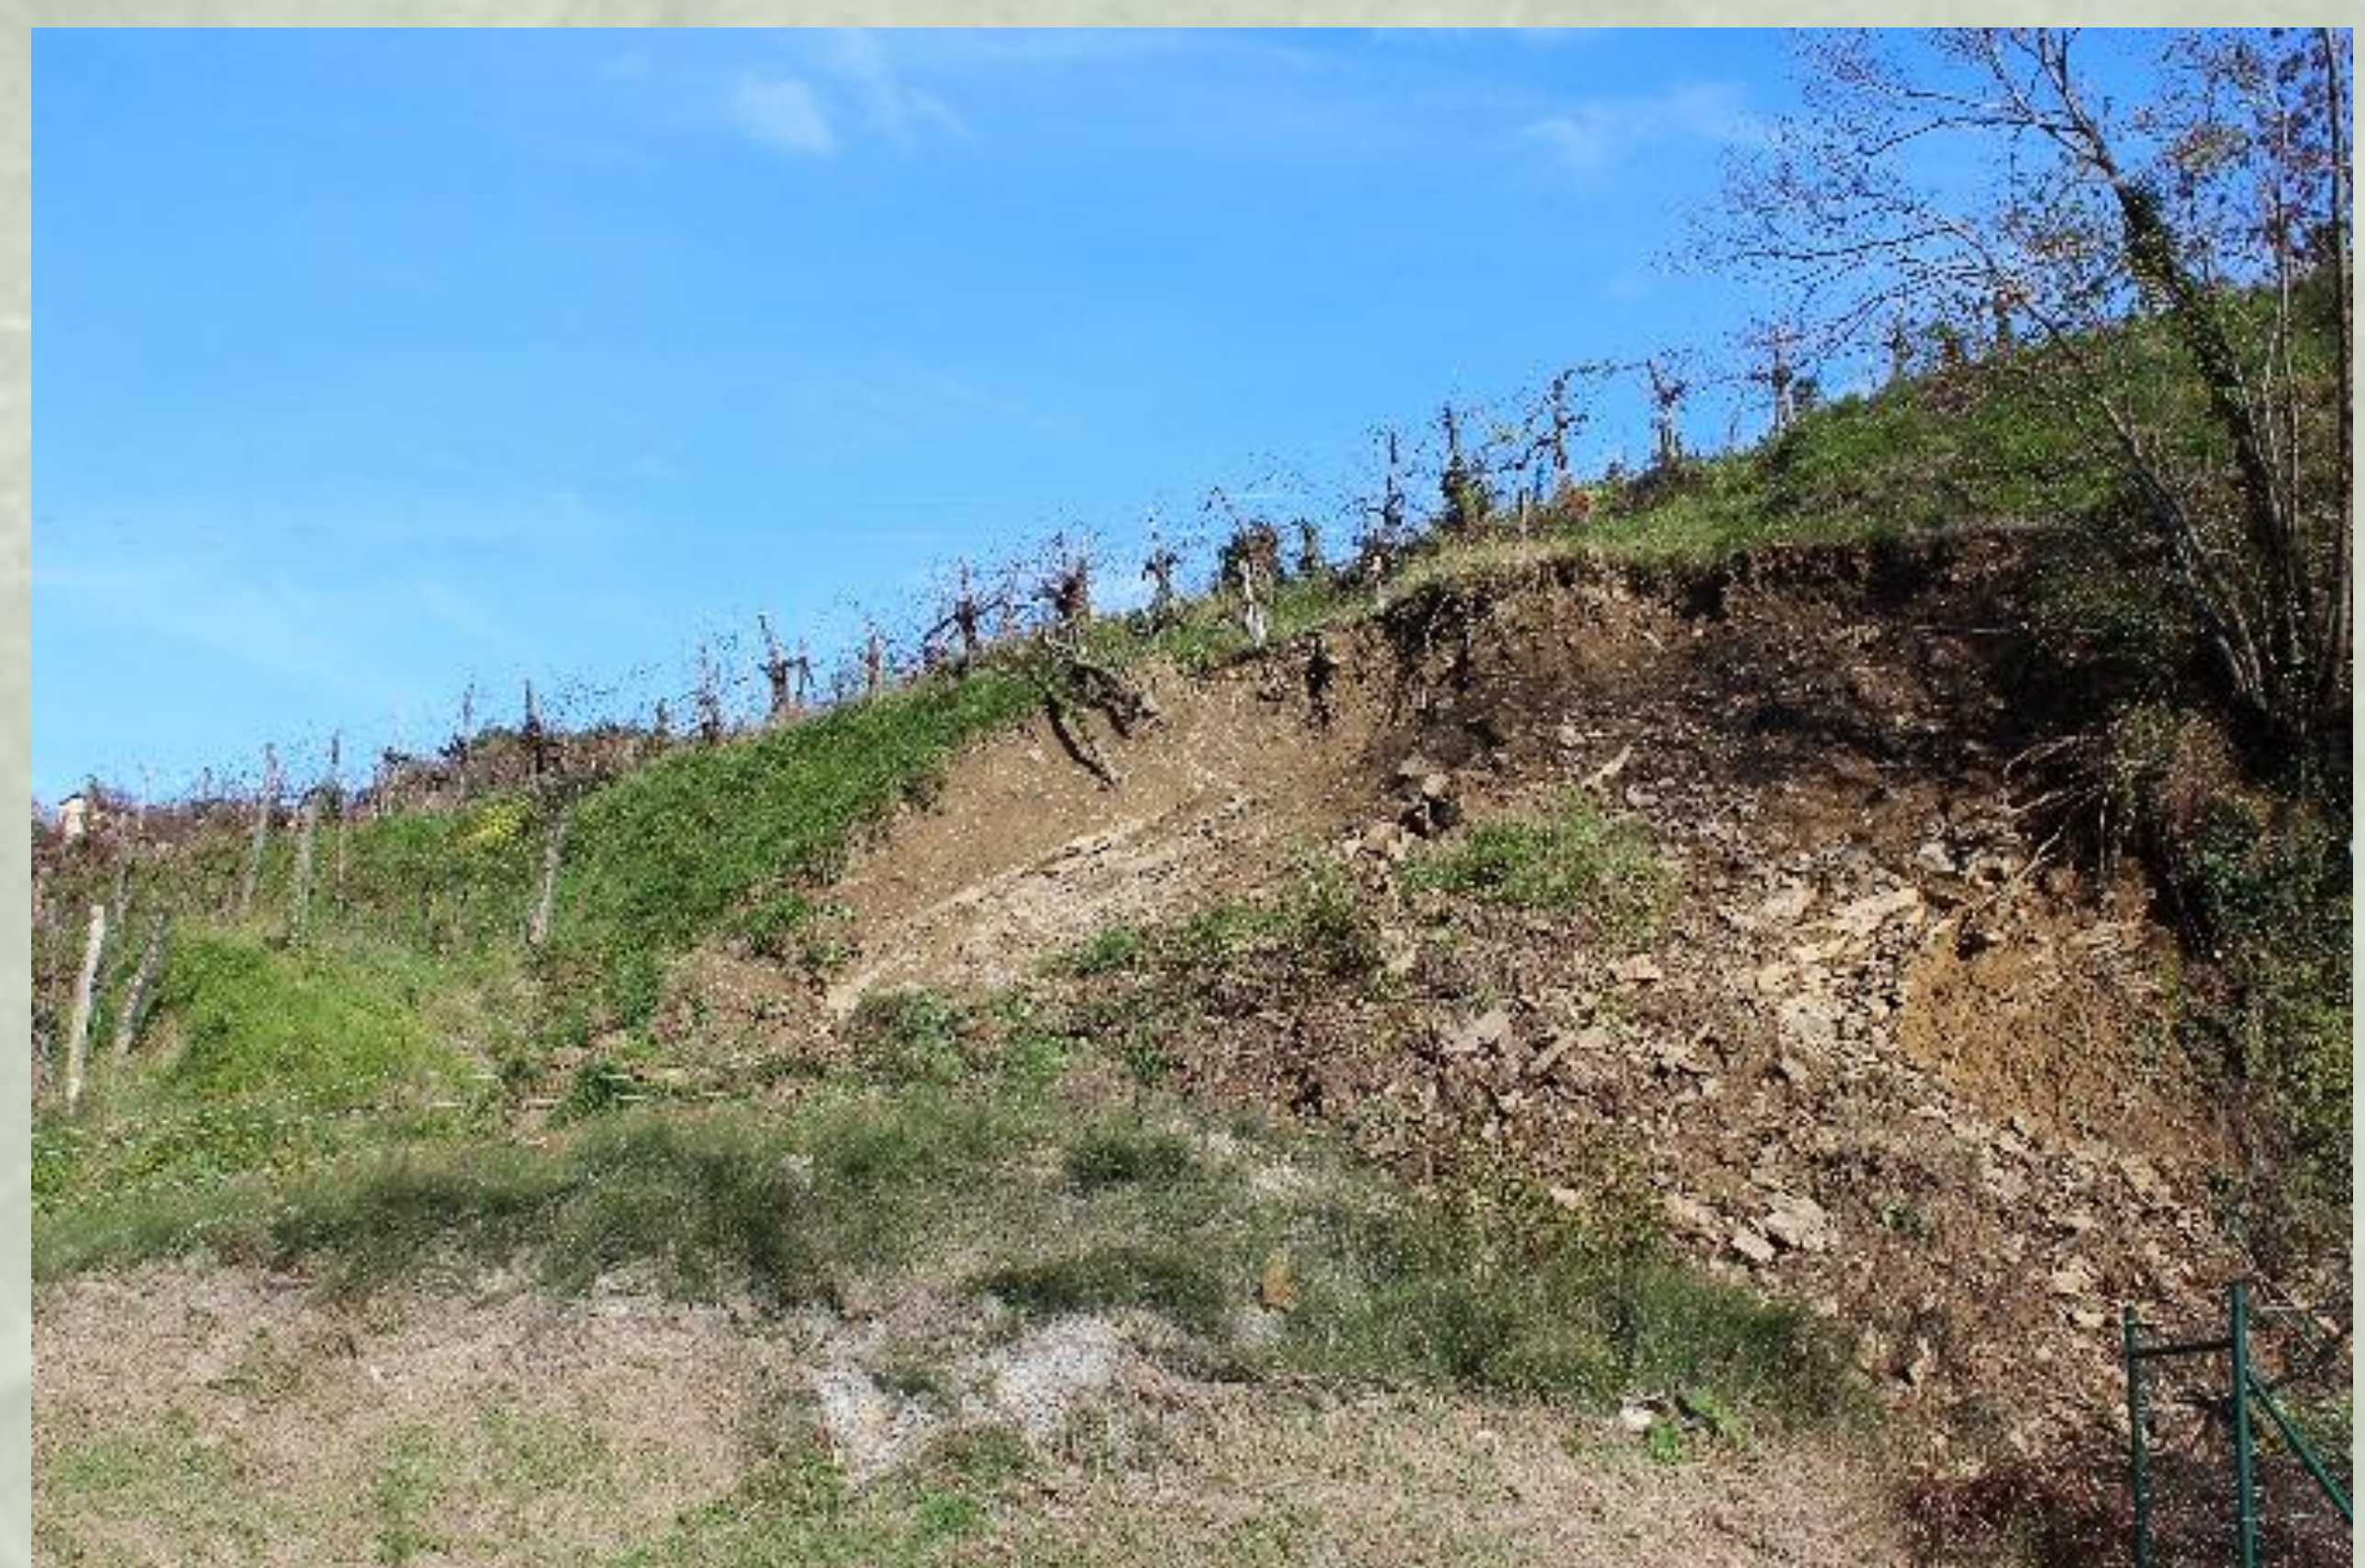
Figures 5 and 6: Landslides in terraced vineyards and Soil erosion during extreme rainfall events in Goriška brda in 2025
